Manhole Inspection Summary

Manhole # S51A__010MH

Insp Date: **6/27/08 11:58 AM**

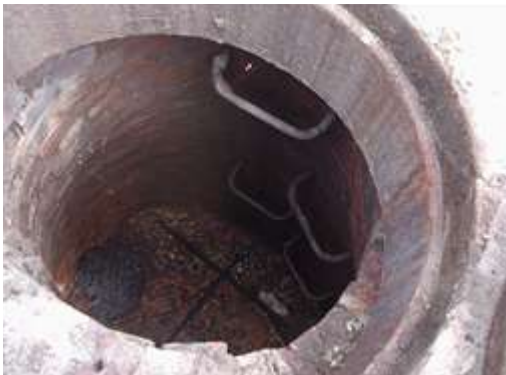
Defect 1

Infiltration: ☐ None ☐ Joint ☐ Cracks ☒ **Mortar** ☐ Roots ☐ Wall

Infiltration: ☐ None ☐ Joint ☐ Cracks ☐ Mortar ☐ Roots ☒ **Wall**

INFILTRATION

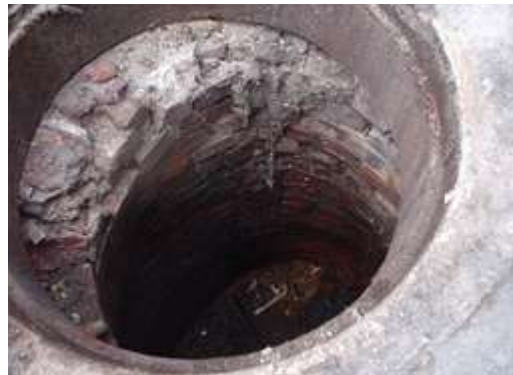
Defect 2

Frame Offset: **6** (in.) Condition: ☒ Sound ☐ Cracked ☐ Leaks

OFFSET FRAME

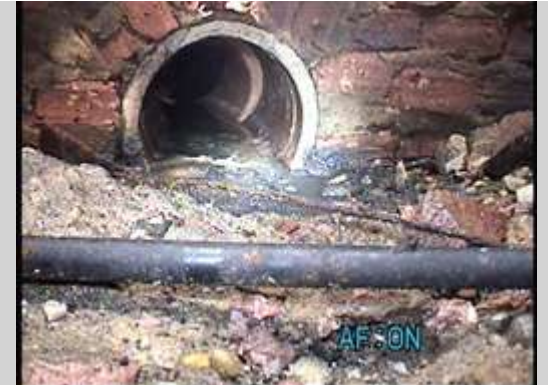
12 O'Clock Outflow

8 in. Circular Gravity Sewer
Pipe Out @ 12 O'Clock

Infiltration: **None** Pipe Seal Cond: **Sound**
